Restoration Study and Re-Use of the Listed ‘Olympios Tower’ and Its Accompanying Buildings in Ano Lechonia, Western Pelion, Magnesia Prefecture, Greece

Fotini Chalvantzi*¹, Ifigenia Dimitriou², Konstantinos Toumpakaris³ and Maria Mageirou⁴

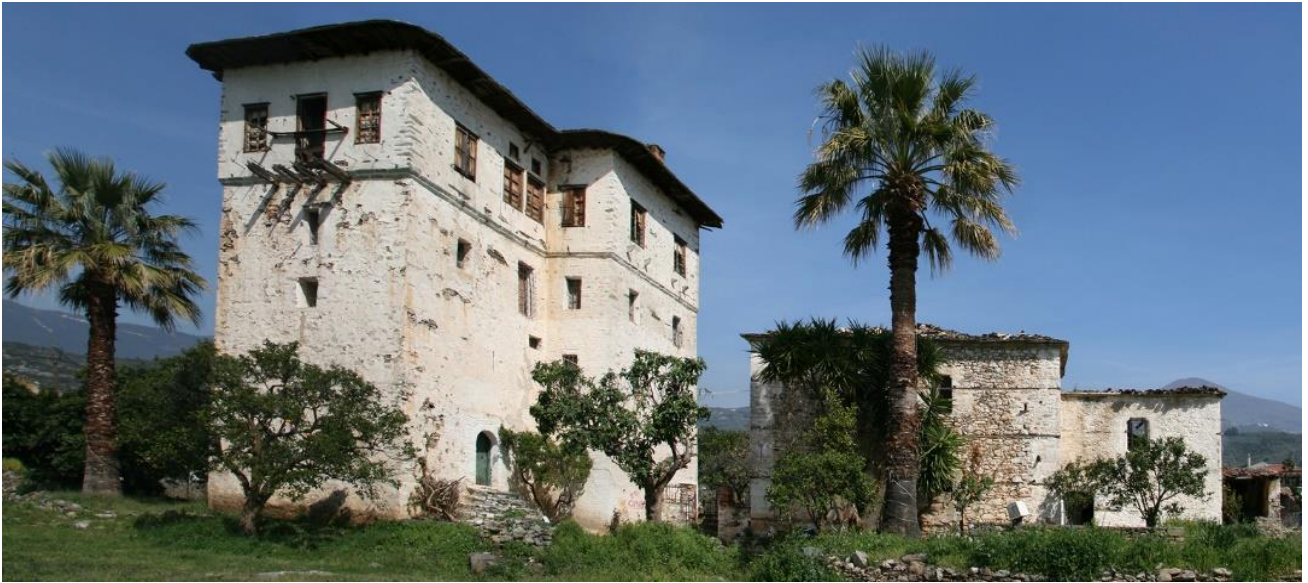
Fig. 1: Southeast aspect of the complex of the listed 'Olympios Tower' (current state)

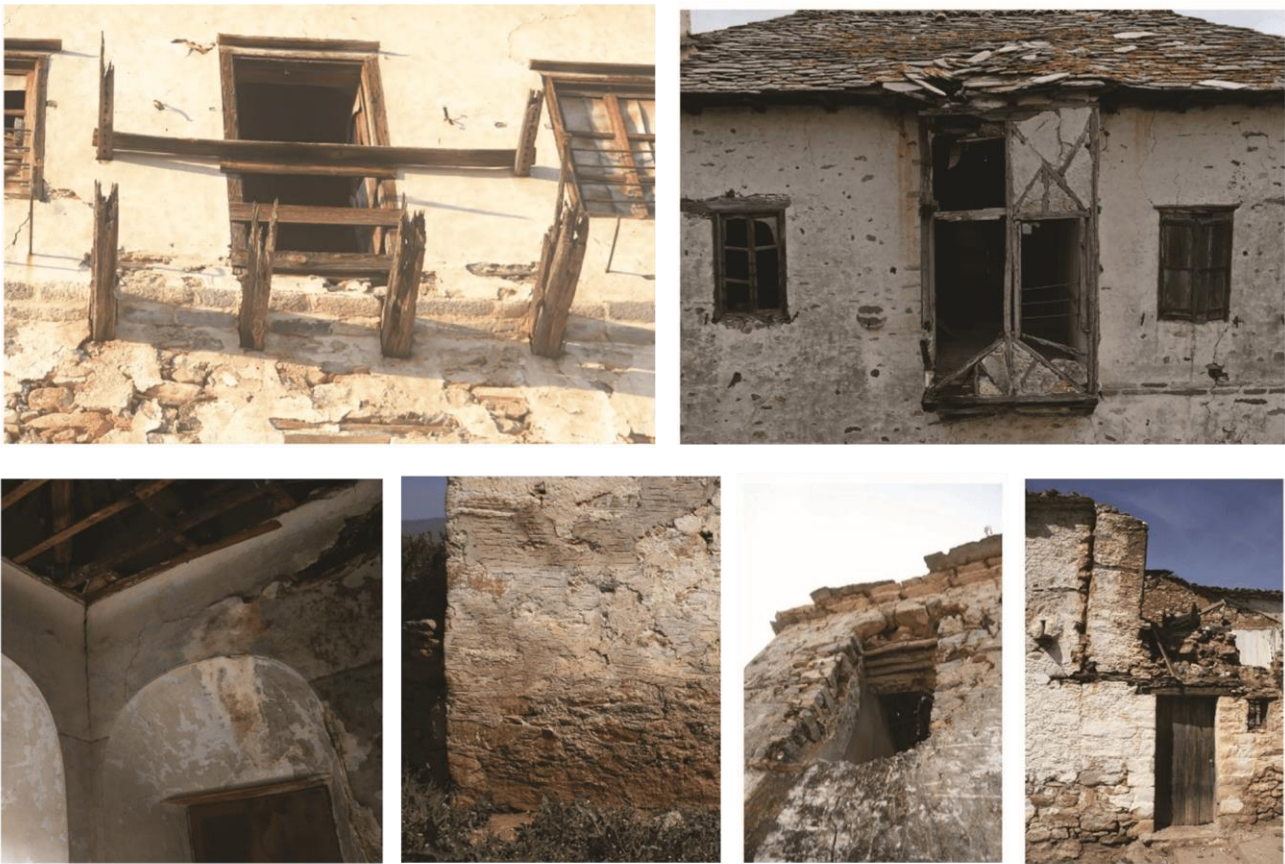
The Tower complex has been abandoned since the 1970s due to a lightning strike in 1967 on the northern part of the Tower. The Tower has adequately coped with the dynamic stresses, and apart from minor structural damages, the stone load-bearing elements of the building show a very good state of preservation. The accompanying buildings are in the

same state of conservation, one of which presents serious structural problems, having completely lost its roof and part of its superstructure.

The structural problems we have identified are summarized below:

- Local disorganisation of joints - leaching of binding mortar - micro-cracks
- Cracks mainly due to lateral thrusts from the roof to the side walls and the Tower
- Corroded and cracked coatings
- Interventions with cement mortars
- Corrosion in masonry reinforcement systems
- Upper-level rafter and eaves have collapsed while the second level central beam and the newer section of the ground floor ceiling have mechanical failure
- Damage to the roof of the Tower and the first wing as well as the total loss of the roof of the second wing.
- Lack of maintenance and partial loss of frames as well as sealing of openings with masonry.
- Total loss of internal scale of the first accompanying building.

Fig. 7: Examples of structural problems of the complex

As a general conclusion of our analyses, we note the excellent response of the tower walls but also the inadequacy of these 'sidewalls', due mainly to the poor structure rather than the geometric inadequacy of the cross-sections. The static analysis of the two buildings was carried out in the Scada-Pro static and dynamic analysis program of American Computers & Engineers - AceHellas by simulating their stone shells with surface finite elements and the beams of the ribbed floors. For the Tower, a seismic behavior coefficient $q=1$ and an A-DL performance level were chosen, while for the accompanying houses 1.5 and B-SD respectively. The inspections of the walls were carried out in accordance with the provisions of Annex C' of EC8 and the draft of the K.A.D.E.T. For the compressive strength of the walls, the KADET_2019 plan was used - §6.2.4.3. With reference to the proposed interventions in the supporting body of the Tower, they are limited and concern the reinforcement, consolidation or recovery of specific provisions. The application of grouts is avoided since, due to the solidity of the core of the walls as well as the excellent condition of the internal plasters, such an intervention is estimated to be more harmful than beneficial for the building. The 'sachnisi' and the balcony of the upper level are recovered, while targeted interventions are proposed on the floors and the roof. The planking is to be completely removed, cleaned and arranged for re-use while the beams are purposefully restored and connected to the walls by suitable metal connectors. With the exception of the lower-level roof, floor joist replacements are minimal and dictated either by the condition found during deforestation, or by in-plane failure of the overlying brick walls. In the case of cracks of significant length, stone joints or joints with stainless steel plates are carried out while external grouting is carried out with suitable hydraulic mortars with a low content of white cement. The ceiling floor of the lower level, in the area of the 2nd phase, is essentially being replaced, with absolute preservation of the axial spaces (the joists, that is, they remain and are re-used) since, in addition to the advanced decay, they are also insufficient in terms of cross-sections. Finally, the main beam on the roof of the second level is replaced by a beam of composite cross-section in which a bending metal beam is integrated, while that of the third level is reinforced with lateral metal plates. With reference to the side door, first of all, the wall that has collapsed is to be recovered as well as the mezzanine and the roof of the spaces to which the specific wall corresponds. Two openings are made for the functional upgrade of the building and the new railings are implemented using wooden beams. The existing mezzanines are to be cleaned and strengthened by replacing some beams which are either mechanically inadequate or in an advanced stage of decay. The beams are connected to the walls by means of iron ties and new planking is installed. The two "independent" shells that make up the accompanying buildings are connected by means of steel anchors and, overall, a three-part grout with a low content of white cement is to be applied.

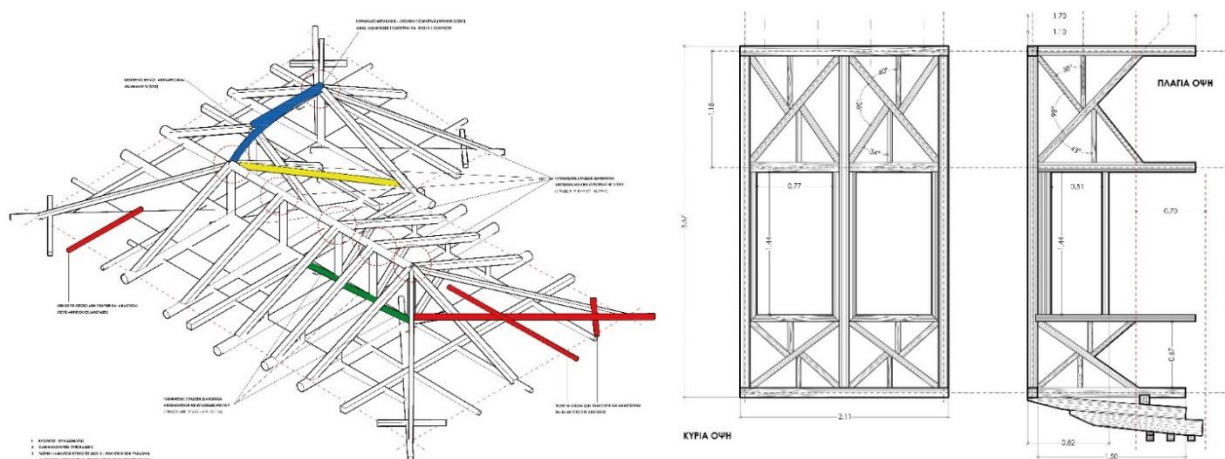
Fig. 9: Proposal Plans: interventions to the bearing structure of the roof and the enclosed balcony

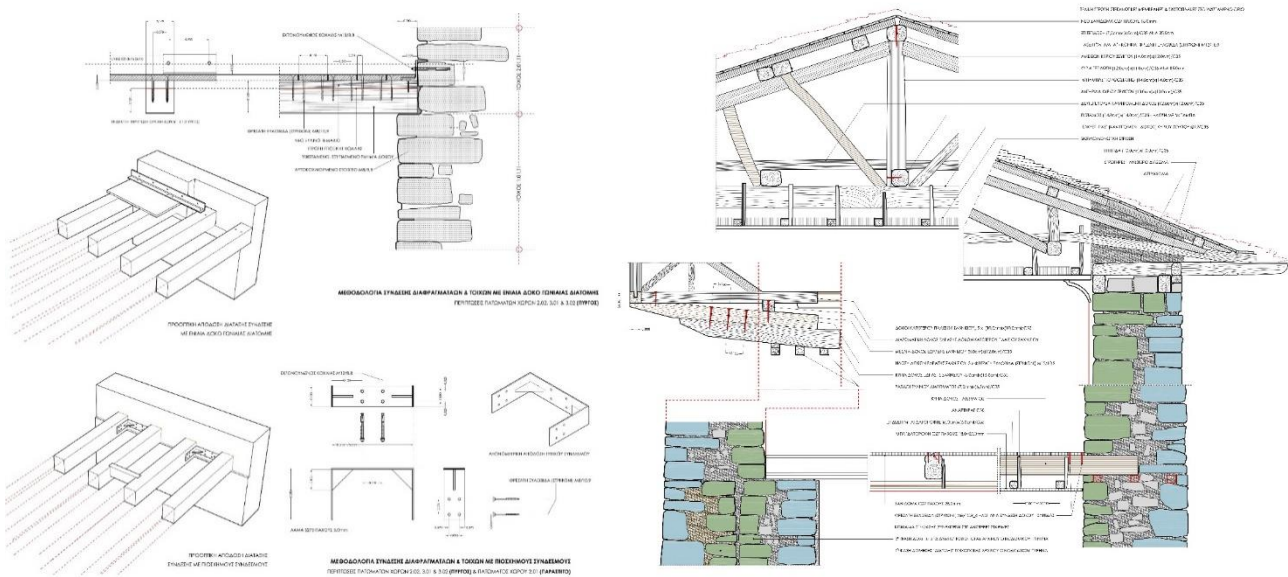
Fig. 10: Proposal Plans: interventions to the bearing structure of the floors, roof and the enclosed balcony
