Restoration Study and Re-Use of the Listed ‘Olympios Tower’ and Its Accompanying Buildings in Ano Lechonia, Western Pelion, Magnesia Prefecture, Greece

Fotini Chalvantzi*¹, Ifigenia Dimitriou², Konstantinos Toumpakaris³ and Maria Mageirou⁴

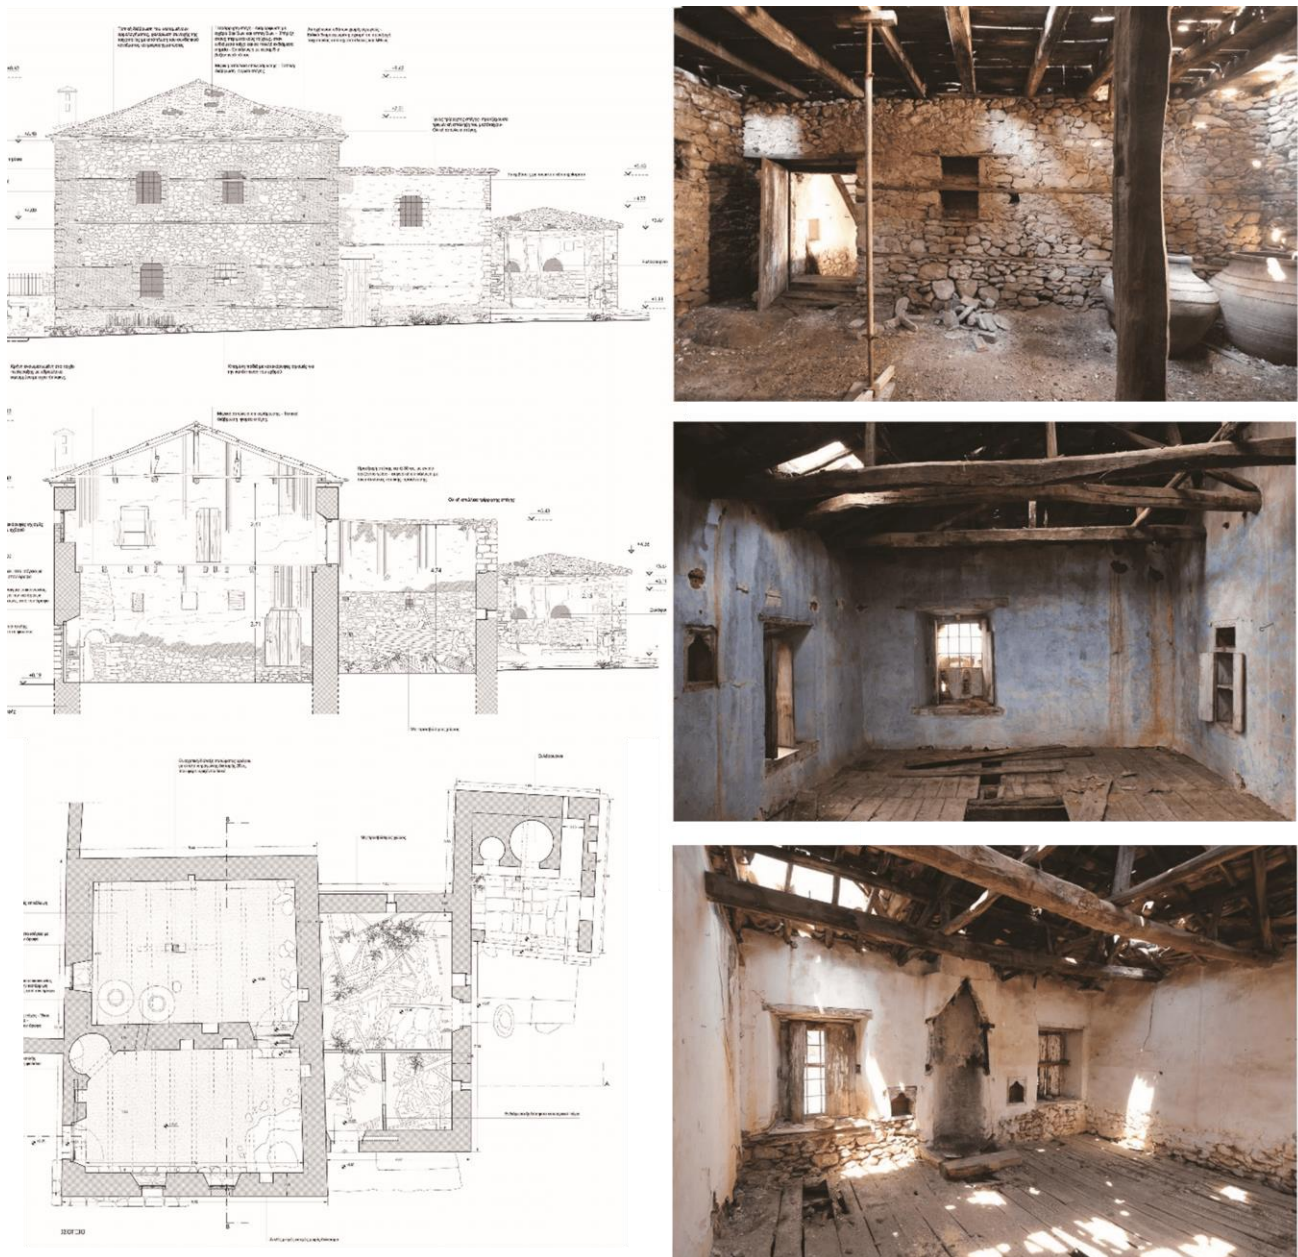
The second side house to the east is in contact with the first, and has two independent entrances from the courtyard. It has a rectangular floor plan with general external dimensions of 5x 9m, wall thickness ~65cm. and common partition with the first side house. Due to the collapse of the roof, its interior is inaccessible.

Fig. 6: Southeast elevation/ longitudinal section/ ground floor plan and interior photos of the accompanying buildings (current state)

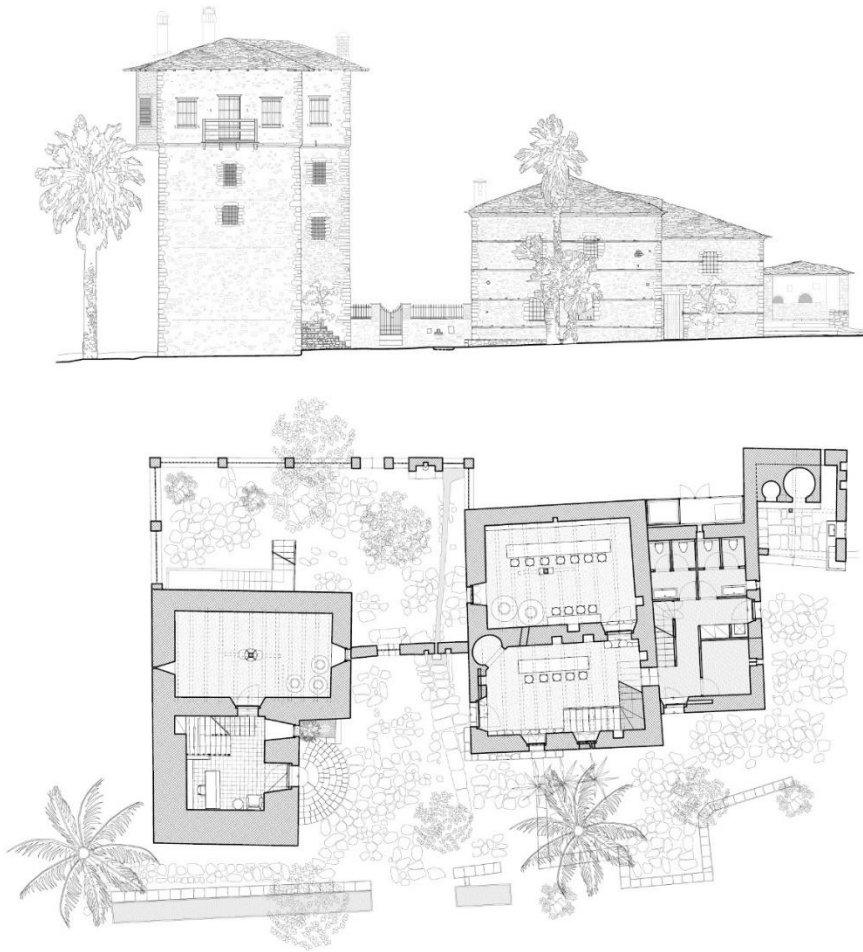
Fig. 8: Proposal Plans: Southeast view of the complex / general plan of the complex

The restoration is based on the idea of a complete restoration of the complex with respect for authenticity and with an emphasis on preserving the typology of the floor plans and all the historical layers. Basic principles for restoration are also the reversibility of interventions and the use of traditional building techniques and compatible materials.
